Bureau of Mines Information Circular/1986

Ground Subsidence and Structural Damage Over an Abandoned Room-and-Pillar Coal Mine at Hegeler, IL

By Gennaro G. Marino, James W. Mahar, Larry R. Powell,
and Richard E. Thill

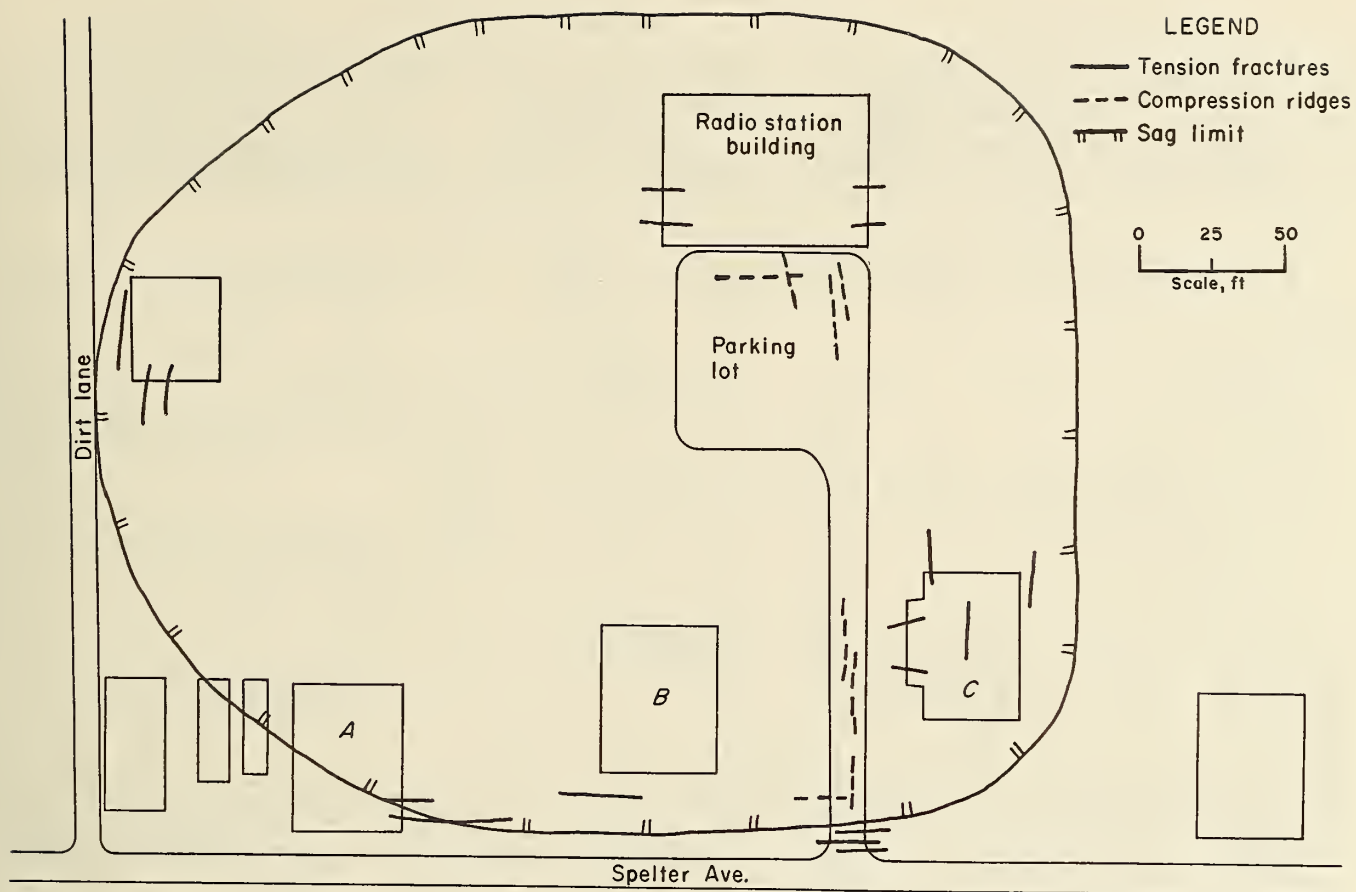
FIGURE 6. - Sketch map of sag 1 tension and compression features in 1967.
(Courtesy of Illinois State Geological Survey.)

The limits of subsidence were determined from (1) a map of perimeter tension cracks and compression ridges prepared by the Illinois State Geological Survey (31) in 1967 (fig. 6), (2) accounts of damage from interviews with radio station personnel and owners of the damaged

house C was located (fig. 8, B-B'). Slopes decrease to the north. Around the radio station building, the maximum slope is roughly 0.02. Both structures are located in the tension zone but on opposite sides of the sag. Curvatures, corresponding to the maximum tension and compression, are $1.2 \times 10^{-3} \text{ ft}^{-1}$ on the south side of the sag and 2.0 to $4.0 \times 10^{-4} \text{ ft}^{-1}$ on the north side. Figure 11 shows tension cracks and compression ridges associated with sag 1.

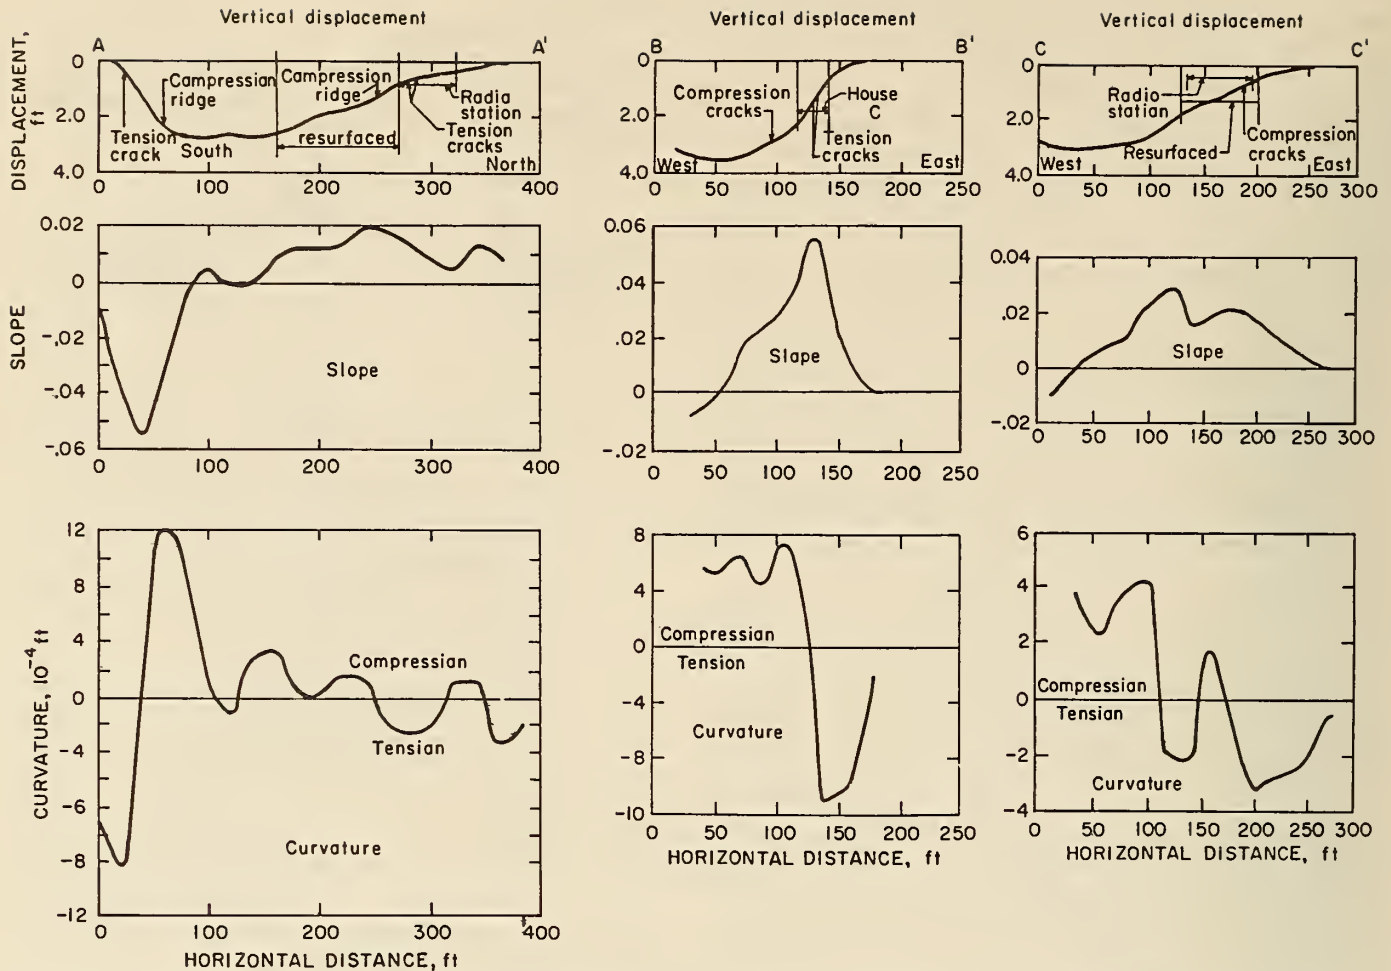
FIGURE 8. - Adjusted profiles, slopes, and curvatures for sag 1. Profile slopes and curvatures calculated on 40-ft lengths from survey data. Surveyed Nov. 11, 1978.

Sag 1 is a 290- by 350-ft semirectangular depression with rounded corners. The area of maximum settlement is approximately concentric to sag limits. A maximum settlement of 3.5 ft is located 100 ft west of profile A-A' (fig. 8). The ratio of settlement to extraction height, known as the subsidence factor, is 0.55.

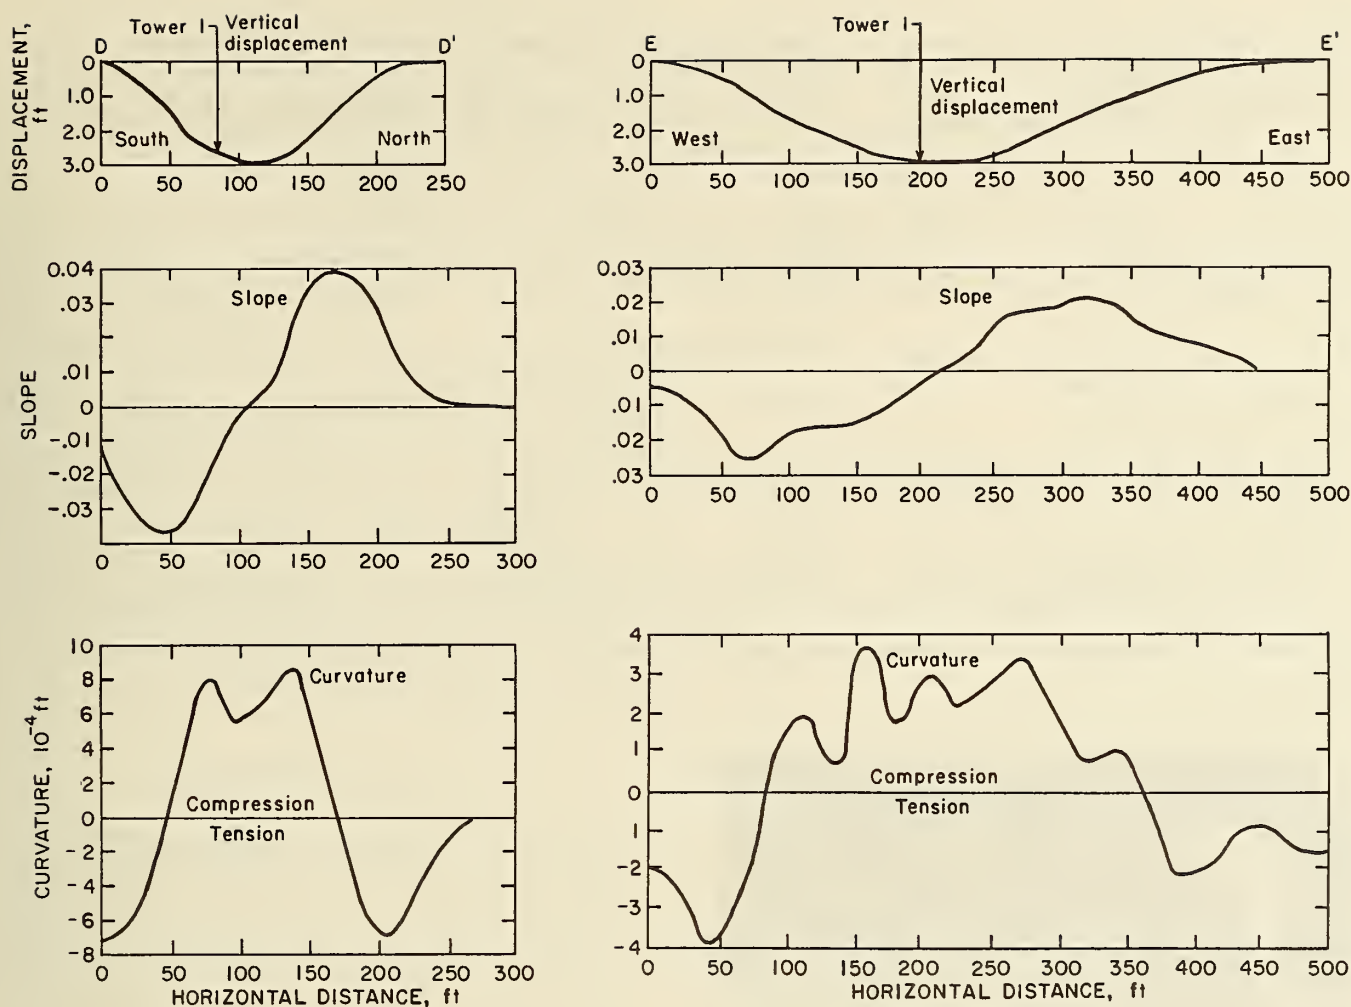
FIGURE 9. - Adjusted profiles, slopes, and curvatures for sag 2. Profile slopes and curvatures calculated on 40-ft lengths from survey data. Surveyed July 9, 1981.

Sag 2 is a 450- by 240-ft elliptical depression elongated in the east-west direction. The sag encompasses the base of tower 1 and most of its guy wire anchors. The adjusted displacement profiles (fig. 9) show the sag to be a bowl-shaped depression with a maximum settlement of about 3 ft.

Slopes for sag 2 are greatest along the north-south profile (fig. 9, D-D') where

the maximum slope is 0.038. This value is 1.5 times greater than the maximum slope in the east-west direction. The maximum curvatures are $8.6 \times 10^{-4} \text{ ft}^{-1}$ in the compression zone and $7.0 \times 10^{-4} \text{ ft}^{-1}$ in the tension zone. Both occur along the north-south profile and are about twice those in the east and west portions of the sag.

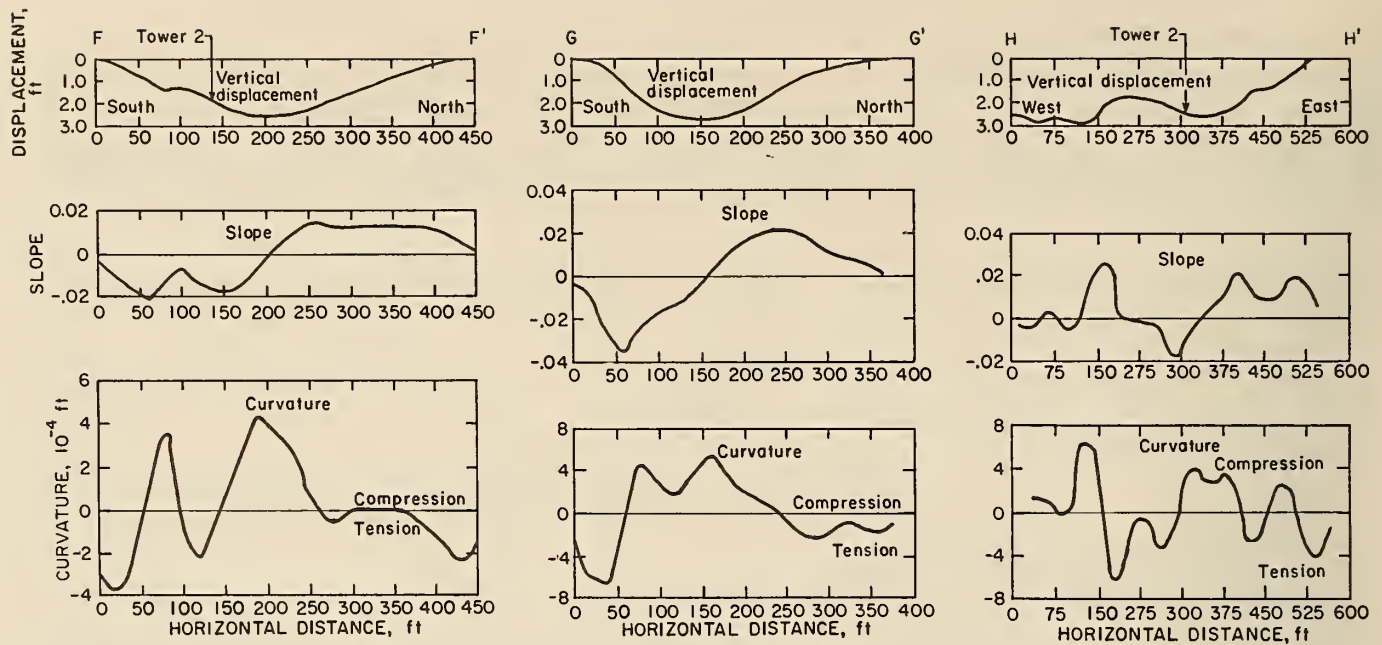
FIGURE 10. - Adjusted profiles, slopes, and curvatures for sag 3. Profile slopes and curvatures calculated on 40-ft lengths from survey data. Surveyed July 9, 1981.

Sag 3 is oval with a maximum east-west diameter of 570 ft and a minimum north-south diameter of 411 ft. The sag encompasses nearly all of tower 2 and the southern guy wire anchors of tower 3. Figure 10 shows that in the north-south direction, the sag has a uniform smooth profile (F-F' and G-G'), but in the east-west direction, the sag bottom varies by 1 ft or more (fig. 10, H-H'). The maximum settlement is 3.0 ft.

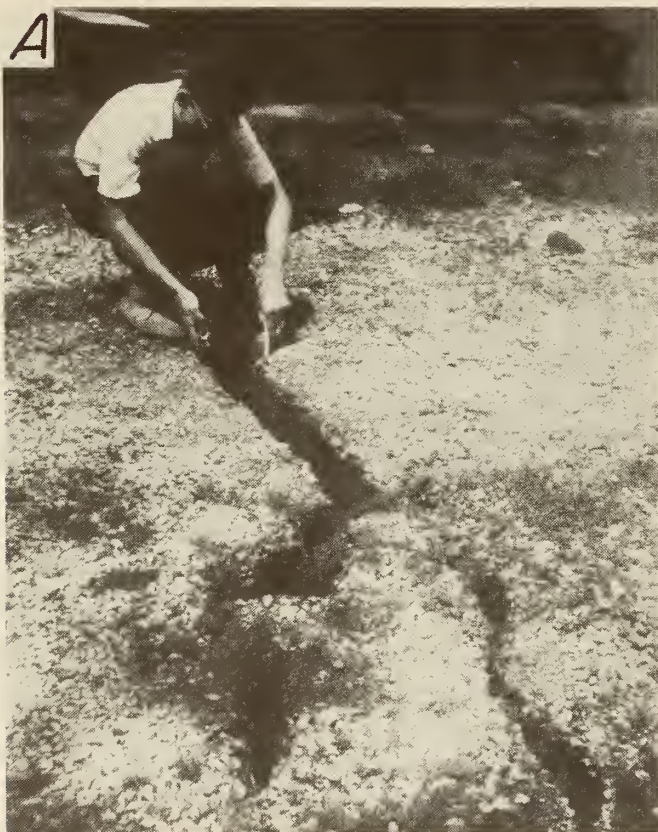
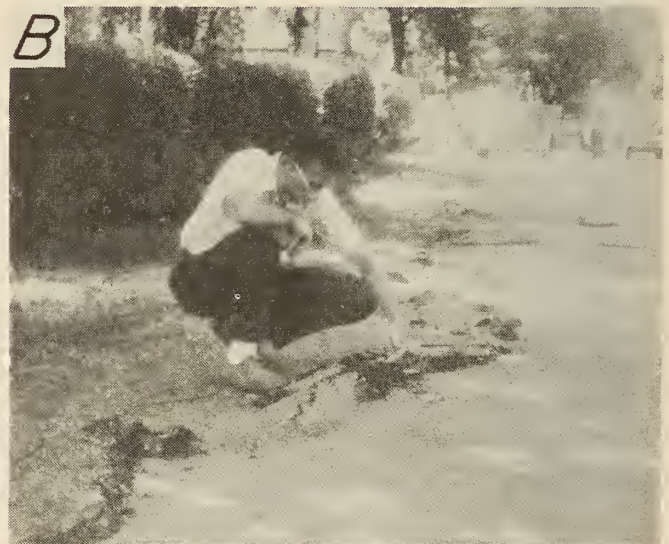
FIGURE 11. - Photographs of 0.33-ft-wide tension cracks (A) and 0.25-ft-high compression ridges (B) from sag 1 on June 24, 1967. (Courtesy of Illinois State Geological Survey.)

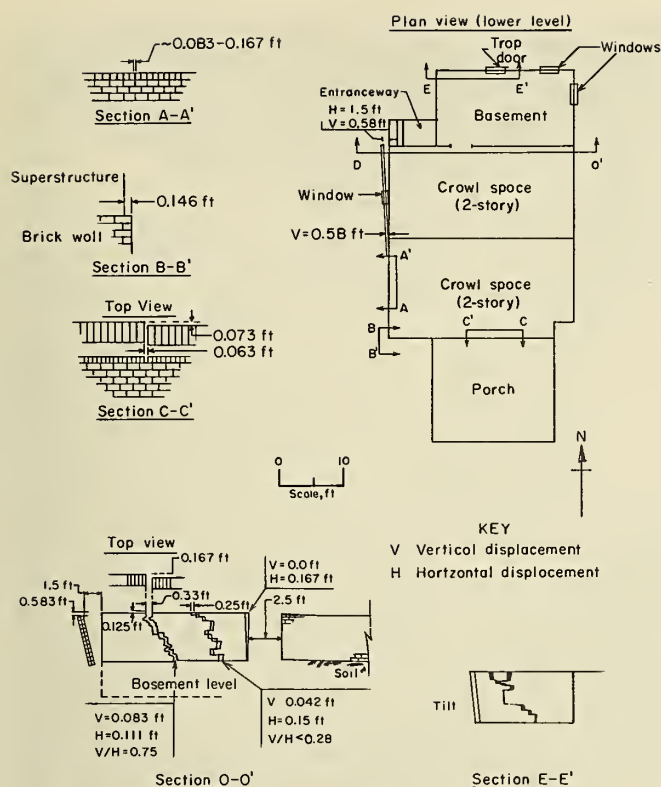
FIGURE 15. - Plan of damage to house C. The damage was measured in May 1978. (Sections shown are not to scale.)

The bearing walls and on-grade members cracked, separated, and tilted in response to the ground movements. Cracks opened as much as 0.33 ft, and walls separated as much as 1.5 ft. The west brick wall of the crawl space tilted, settled, and moved laterally away from the superstructure (fig. 15, sec. D-D'). At the north end, it separated horizontally 1.5 ft and vertically 0.58 ft from the interior bearing wall. These wall displacements occurred because there was no foundation-superstructure attachment between the exterior and interior walls. The vertical separation prevented the development of frictional resistance between the sill and wall, thus there was essentially no restraint against outward movement. Most of the damage to the west

The relationship between profile slope and wall tilt is illustrated by the wall separations and crack widths in the northwest corner of the basement (fig. 15, sec. E-E'). Here crack widths and wall separations are two to three times greater at the top than at the bottom. The average tilt of the north and west walls is estimated to be about 0.08. This is comparable to the slope of 0.07 calculated for this section of the sag.

Figure 15, section C-C', shows that the south bearing wall has undergone displacements similar to the north wall. The crack in the south wall has a low vertical-to-horizontal displacement ratio. Measurements of the vertical crack separation on both the north and south

The northward horizontal ground movement caused the superstructure to move north with respect to southern foundation walls. A horizontal offset of 0.15 ft was measured between the superstructure and the west end of the south bearing wall (fig. 15, sec. B-B').

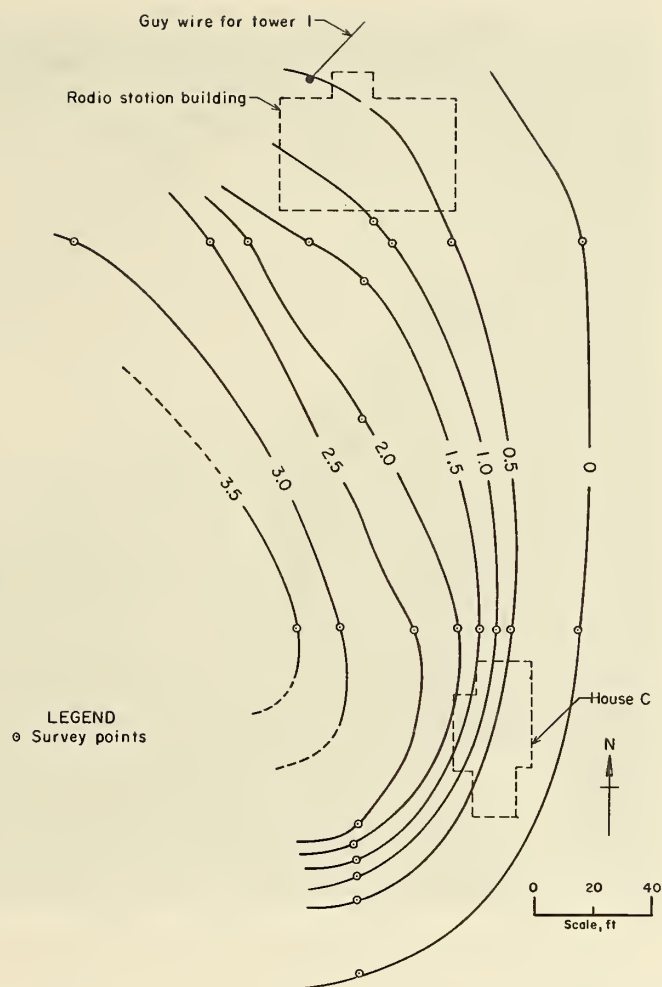
FIGURE 16. - Vertical-displacement contours for sag 1. Survey performed in November 1978.

The house was located in the tension zone just inside the southeast corner of sag 1 (fig. 6). Vertical-displacement contours related to sag 1 are shown in figure 16. The ground movements subjected the house to large horizontal strains, angular distortions, rigid body tilt, and translation. Profile B-B' in figure 8

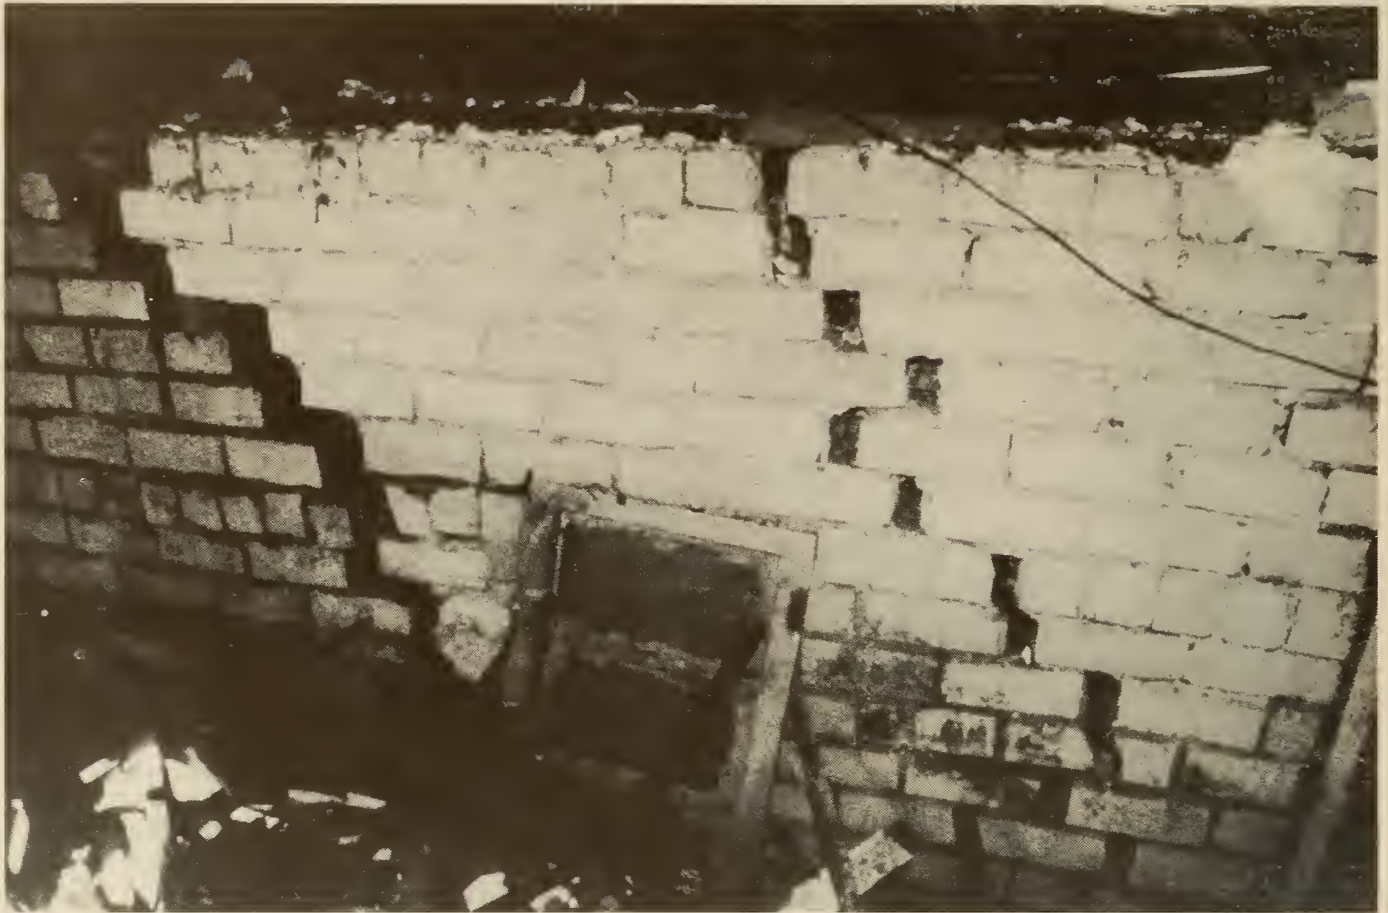
Figure 17 shows the western part of the north interior wall of the crawl space (also figure 15, section D-D'). The ground movements produced two major diagonal cracks in the wall. At floor level, the west crack opened 0.11 ft

FIGURE 17. - North bearing wall of crawl space in house C in 1978 (looking north). The picture shows the change in the nature of separation of the two cracks in the west portion of the wall. Refer to section D-D' in figure 15.

horizontally, and the east crack opened 0.15 ft. Both cracks increased about 0.08 ft in width from bottom to top in response to rigid body tilt. The western crack had a vertical displacement of 0.08 ft that developed as a result of angular distortion. The eastern crack was affected more by horizontal ground movement. This is demonstrated by comparing the ratios of the vertical-to-horizontal crack width (V/H), which is 0.75 for the west crack and 0.28 for the east crack. The west crack also has 0.17 ft of north-south offset at the top.

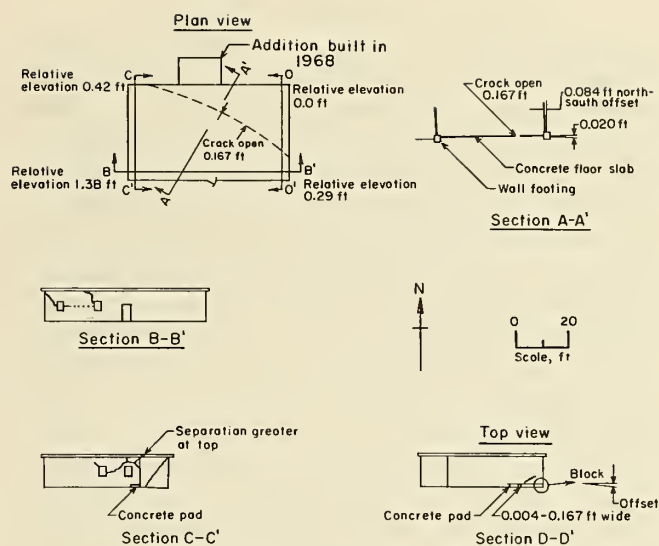
The southwestward horizontal ground movements caused cracking and separation of the foundation and floor slab. A vertical crack in the concrete floor opened 0.167 ft and is oriented subparallel to the vertical-displacement contours (fig. 18, sec. A-A'). The superstructure was

FIGURE 18. - Plan of damage to radio station building. The damage is not inclusive. The relative elevations on the structure were surveyed on July 30, 1967.

displaced horizontally along with the southern part of the foundation. On the north wall, the superstructure failed in shear along the mortar joint just above the foundation and was offset 0.083 ft southward relative to the footing. In addition, the southwest corner of the building was offset by the southwest movement of the foundation. The superstructure appears to have been subjected to angular distortion and tension. The torsional deformation was produced by a change in direction and magnitude of ground movements from south to southwest within the building.

About 80 to 90 pct of the damage occurred within 2 days after the initial movement. The damage included jammed doors and windows, a tilted front wall, and cracks in the floor slab, foundation, and exterior masonry block walls. Several months later, the building was remodeled. This work included a false floor, interior repairs, exterior siding, and a brick facade. A permanent shoring system was also installed to support the south wall.

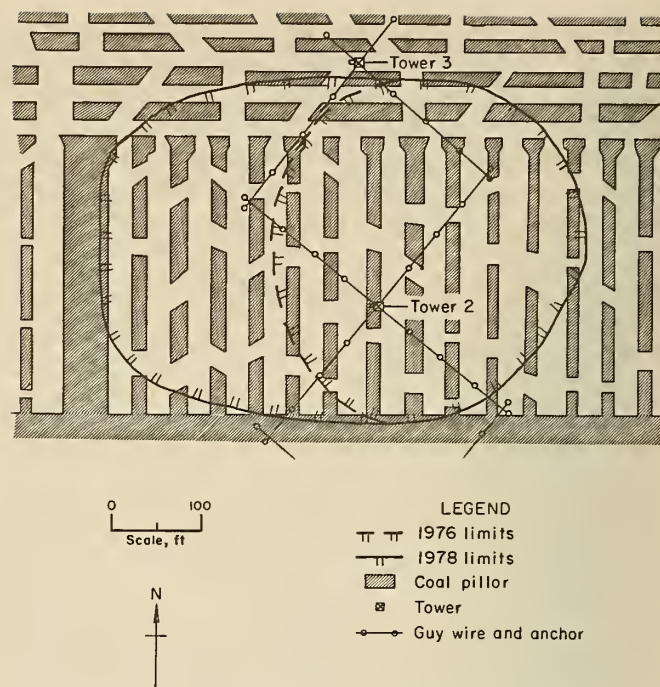
FIGURE 19. - Postulated progression of subsidence associated with sag 3.

The formation of sag 3 affected towers 2 and 3. The eastern part of the sag developed in late 1976. It encompassed the base of tower 2, most of its guy wire anchors, and the southeast set of guy wire anchors for tower 3 (fig. 19). In addition to settlement, the base of tower 2 tilted 0.5 ft and moved northeast. At this time, most of the tower 2 guy wires were loose, and failure of the tower was a major concern. The southeast guy wires of tower 3 tightened as their anchor blocks were pulled southward by the ground movements. Guy wire adjustments were made twice, and new ground transmission wire systems were installed

In July 1978, additional subsidence occurred, and sag 3 developed in a westerly direction (fig. 19). The renewed subsidence caused additional settlement of the tower 2 base. The cumulative settlement of the tower 2 base is 2.5 ft. The additional movements in sag 3 produced tightening of tower 2 and 3 guy wires. The upper 150 ft of tower 3 was bent as a result of the southwest pull of the guy wire anchor blocks. Guy wires to both towers were retensioned.
